ERDC/EL TR-04-10

*Dredging Operations Technical Support Program
Monitoring Completed Navigation Projects Program*

Guidance and Lessons Learned from Monitoring Completed Navigation Projects

ERDC/EL TR-04-10
June 2004

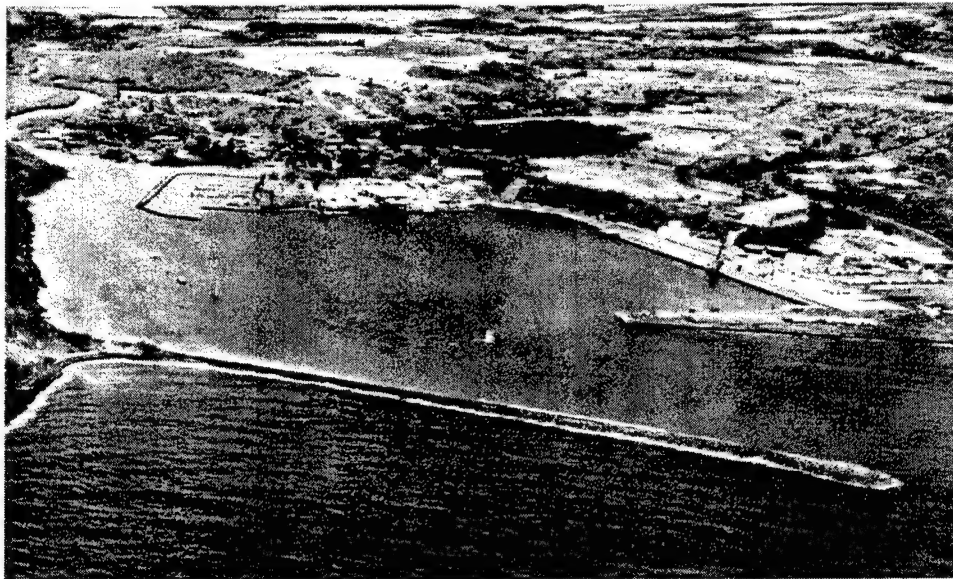
Figure 1. Nawiliwili Harbor, Kauai, HI (after Bottin and Meyers 2002a)

- b.* A total of 70 broken/cracked concrete armor units were identified in the 1995 survey, and 77 broken/cracked units were identified in 2001. However, high-wave action during the 1995 waking inspection prevented a close examination of armor units at the water's edge. Of the seven additional broken units in 2001, six were located along the water's edge and may have been broken in 1995 as the result of the excessive wave action. Therefore, it appears that minimal armor unit breakage occurred between 1995 and 2001.

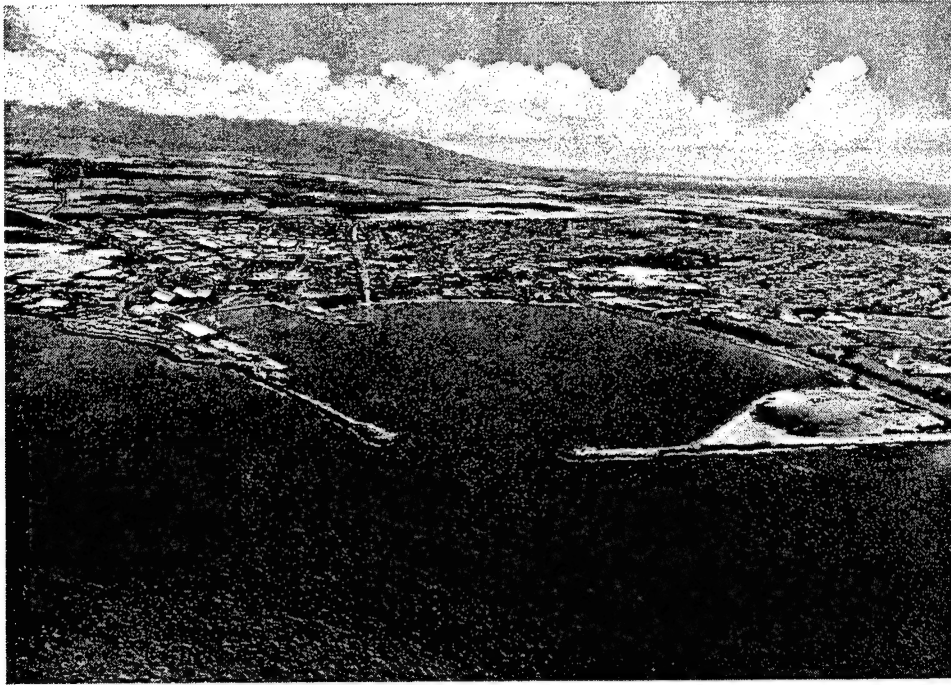
Figure 2. Kahului Harbor, Maui, HI (after Bottin and Meyers 2002b)

breakwater. An inspection in 1973 revealed that 29,965-kg (33-ton) tetrapods on the sea side of both heads had sustained considerable damage and they, along with the 7,265-kg (8-ton) stone areas on both trunks, were in need of repair.

- b. For the west breakwater, however, comparisons of target coordinates showed relatively close agreement with those obtained in 1993. The average movement of all targets in both the horizontal and vertical directions was less than 0.02 m (0.5 ft). Considering the movements of targeted armor units' centroids, average movements in both the horizontal and vertical directions were less than 0.2 m (0.6 ft) for the east breakwater, and less than 0.1 m (0.4 ft) for the west breakwater.
- c. A total of 29 broken/cracked armor units on the east breakwater and 58 on the west breakwater were identified during the 2001 survey. These data establish a base from which to evaluate future breakage in subsequent surveys. The areas of concentrated breakage on the Kahului east and west breakwaters should be inspected annually to monitor any increase in breakage and thus reduction in stability.

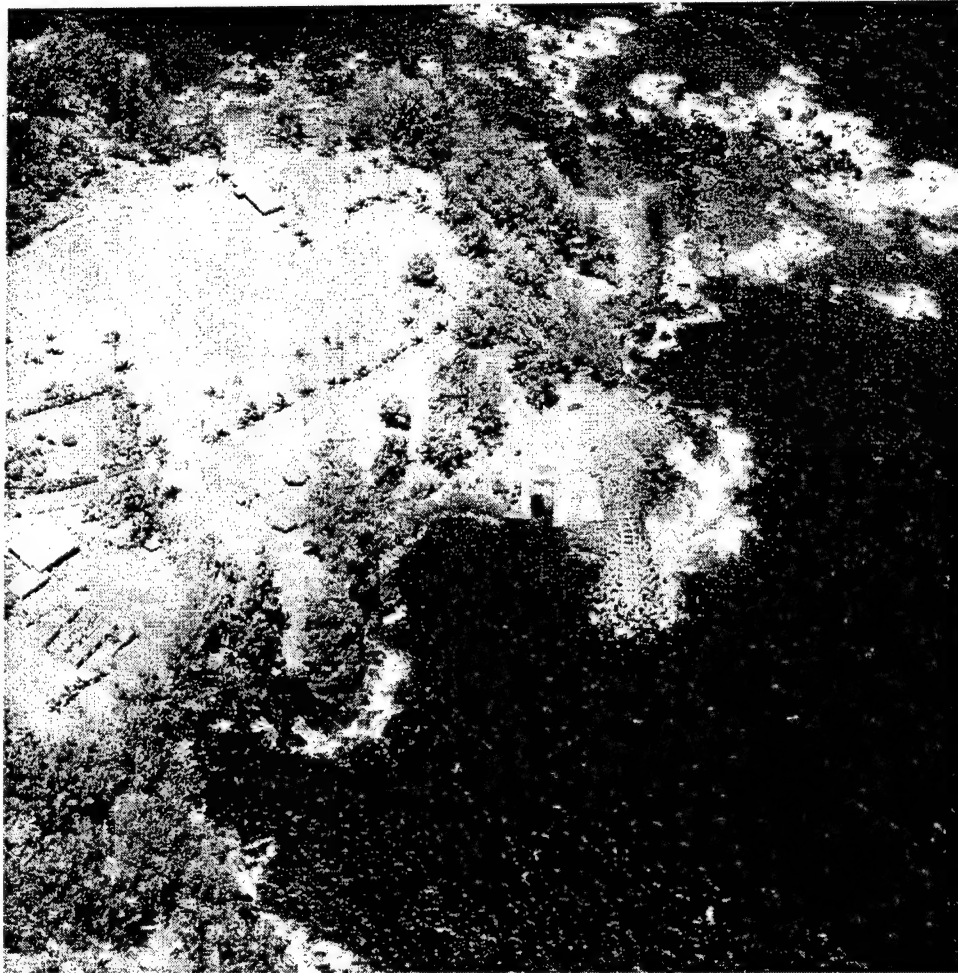
Figure 3. Laupahoehoe Boat Launching Facility, HI (after Bottin and Meyers 2002b)

- a. Similar data were obtained during 2001 and compared with the 1993 data. An analysis of these data indicated negligible movement on the breakwater.
- b. Average target movement in both the horizontal and vertical directions was less than 0.1 m (0.2 ft). Considering the movements of targeted armor units' centroids, average movements in both the horizontal and vertical directions were around 0.03 m (0.1 ft) for the Laupahoehoe breakwater.
- c. No broken/cracked armor units were found on the Laupahoehoe breakwater.

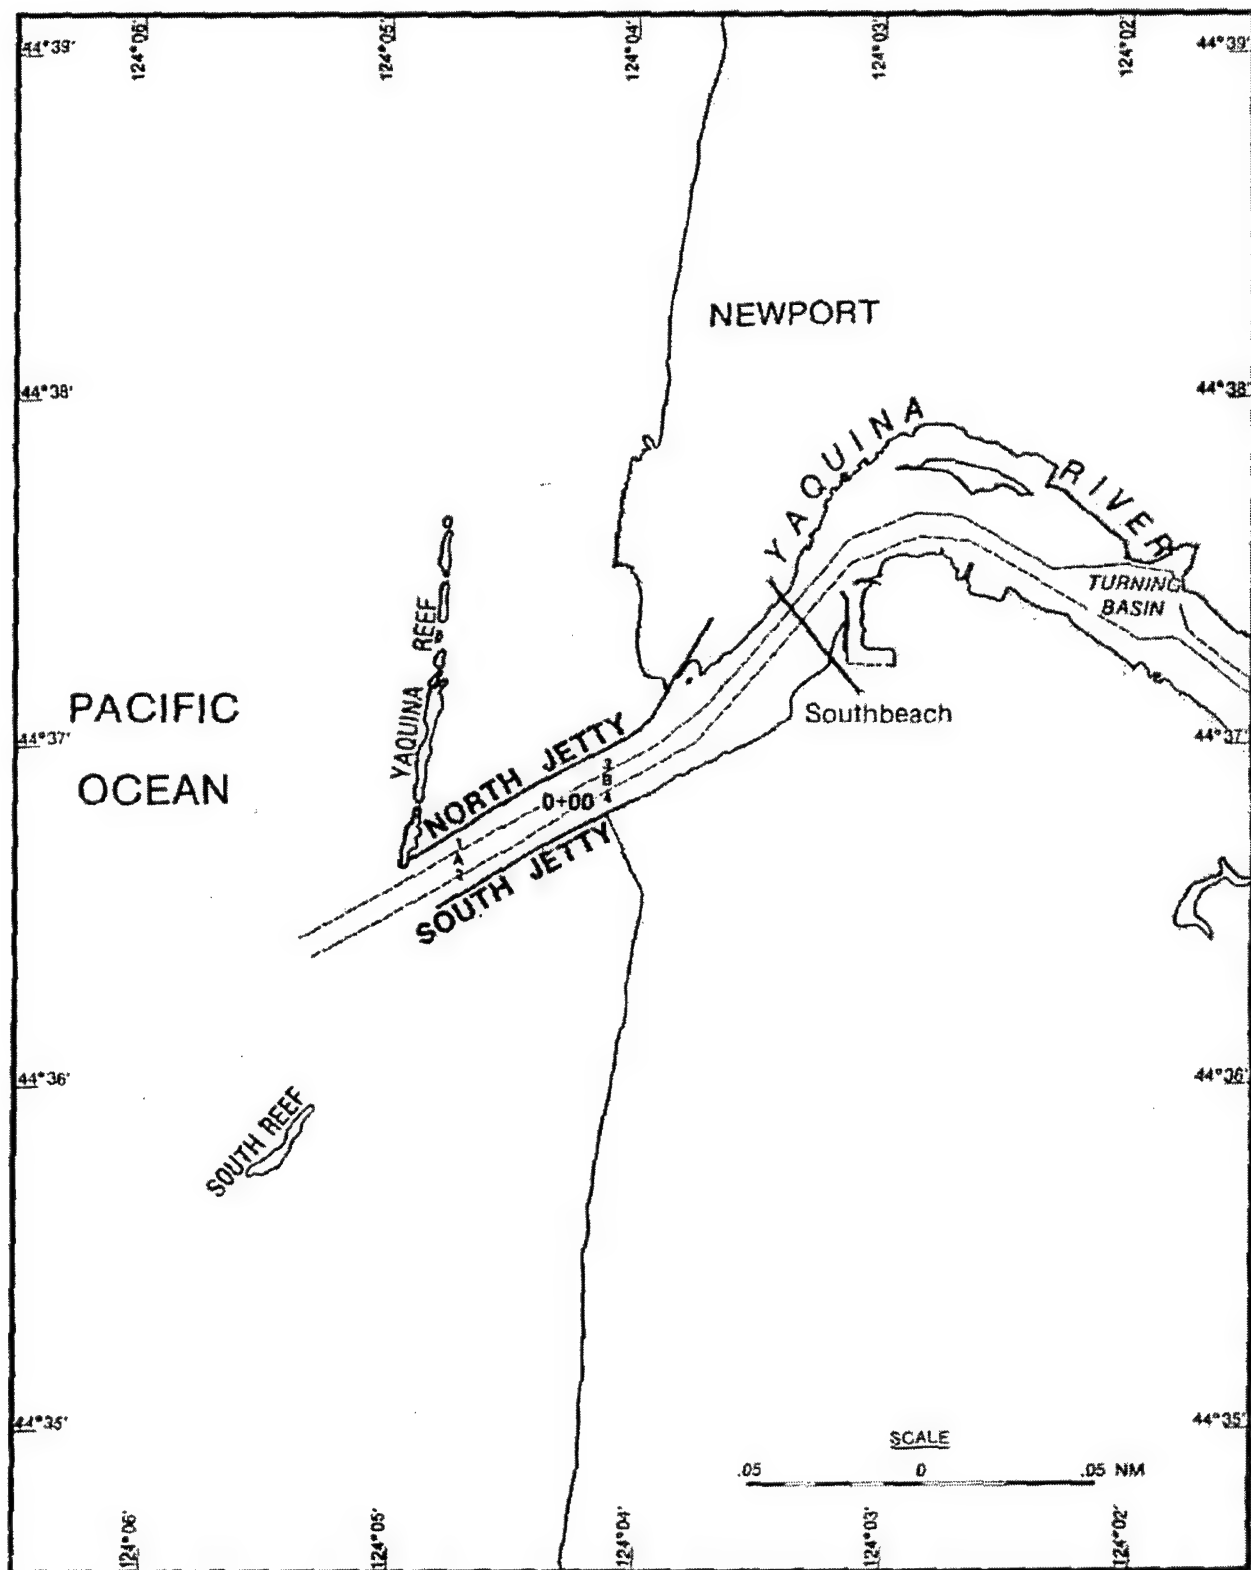
Monitoring was conducted during the time period October 1988 – September 1994 to determine the likely cause for chronic damage to the Yaquina Bay north jetty. This monitoring also offered the potential for increasing understanding of failure mechanisms associated with rubble-mound structures and for improving methods of monitoring coastal structure performance in similar hostile wave and current environments (Hughes et al. 1995).

Figure 15. Yaquina Bay, Newport, OR (after Hughes et al. 1995)

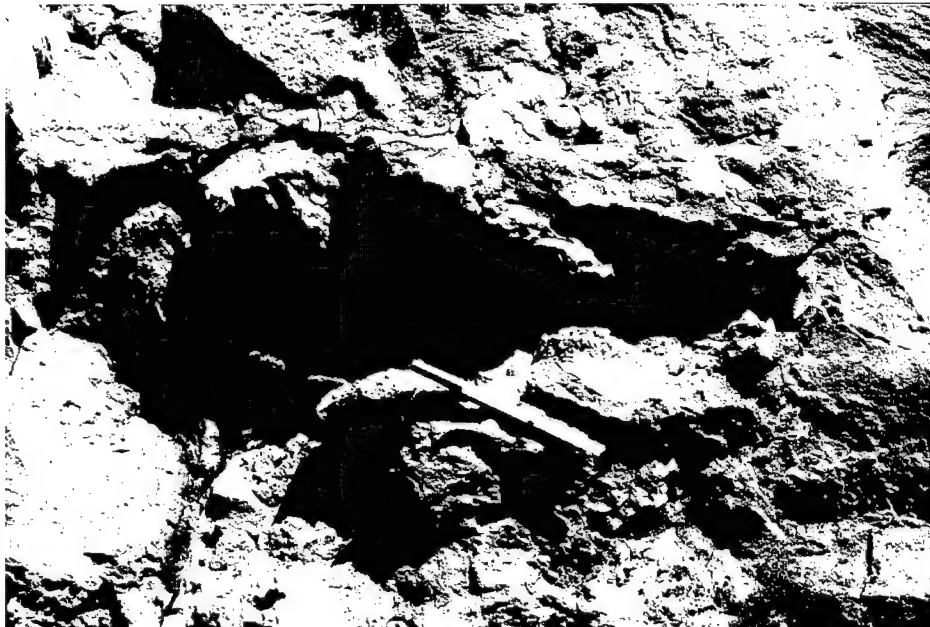
A survey of breakwater stone structures in the Great Lakes in 1990 indicated various degrees of excessive and premature stone deterioration (Figure 37). In some stones, the damage was significant and required costly rehabilitation of the structures far in advance of the expected economic life of the structures. Other stones were apparently performing well. The study initiated an effort to determine practical ways to reduce the amount of stone deterioration, lengthen the economic life of coastal structures, and to reduce the annual cost of maintenance. The study also compared changes in performance of the stone that resulted from inherent weaknesses such as diagenetic or depositional environment (facies) and fractures resulting from extraction methods at the quarries.

Figure 37. Great Lakes breakwater stone deterioration (after Richards et al. (in preparation))
